3809 REPORT OF INSPECTION

51047/050

Date: April 27, 2005 Time: about 9:20 pm Location: T.5S. R.24E. Sec 6 S2 of Lot 8

Serial no. of notice: UTU 66358 (Hiko Bell expired project area) Is the operation active? No

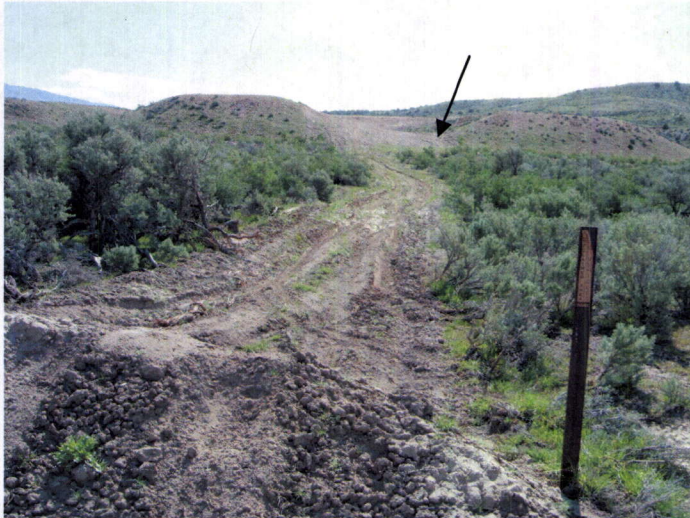
< image 1 view to east of west end of ripped road (constructed by earlier UTU66358 operator). A mound and "reclaimed area, no vehicular traffic" sign is shown in foreground. Track and ruts are indications of vehicular travel on the ground that has undergone reclamation. Arrow points at an area enlarged in image __ below

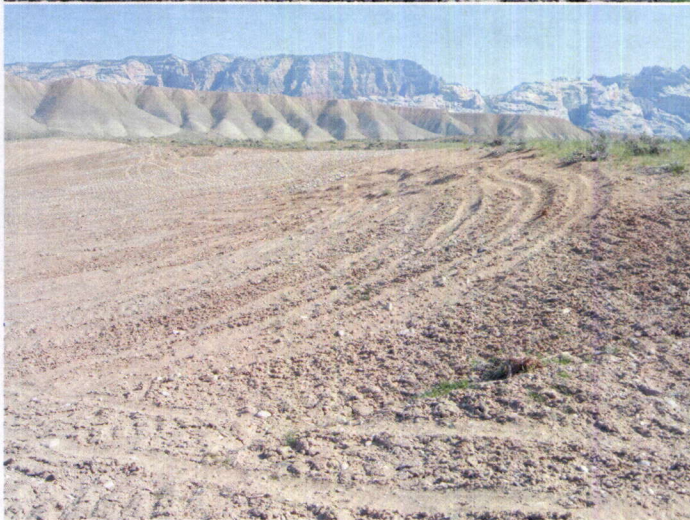
< image 2 view to north (from near the southeastern corner of the area undergoing reclamation) showing the tracking by ohv's and other wheeled vehicles have caused (on the area that had undergone reshaping and seeding)

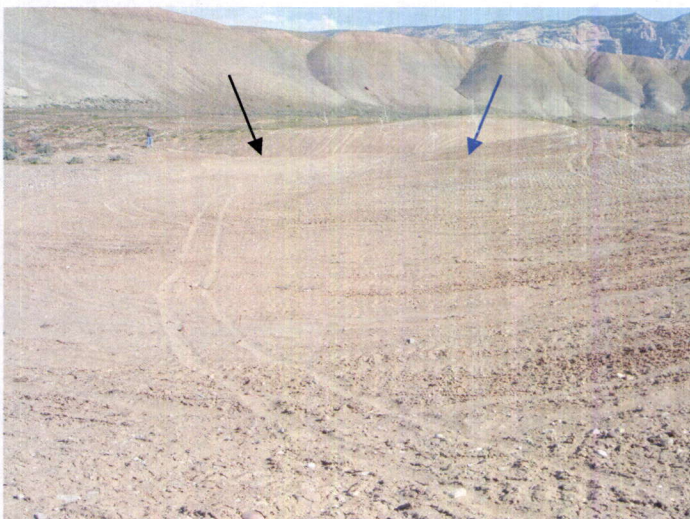
< image 3 view to north-northwest (pan to left of image 2). Reshaped and seeded area has been tracked by vehicular travel.

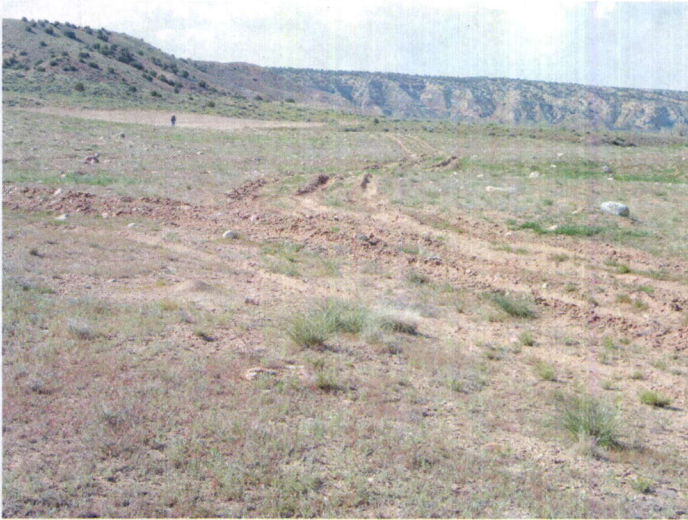
< image 4 view to south of rutting by vehicles along the access that had connected project areas UTU66354 and UTU66358 (determined to have been part of the 66358 project area).

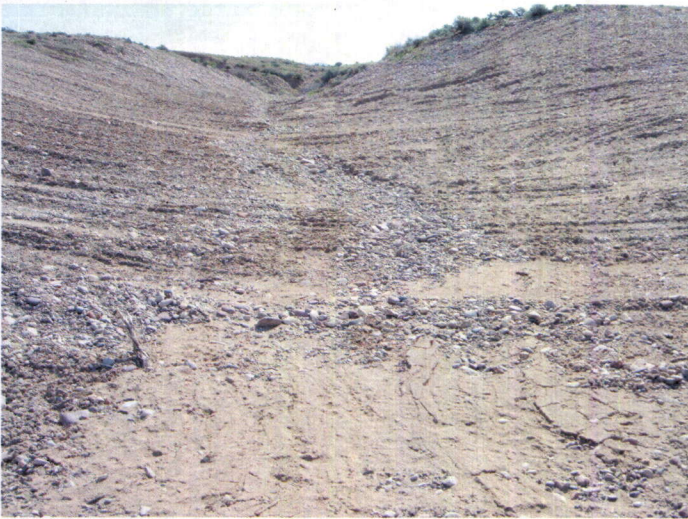
< image 5 view to east of intermittent drainage (pointed to by black arrow in image 3) that has had water flow through it since the reshaping of the expired project area.

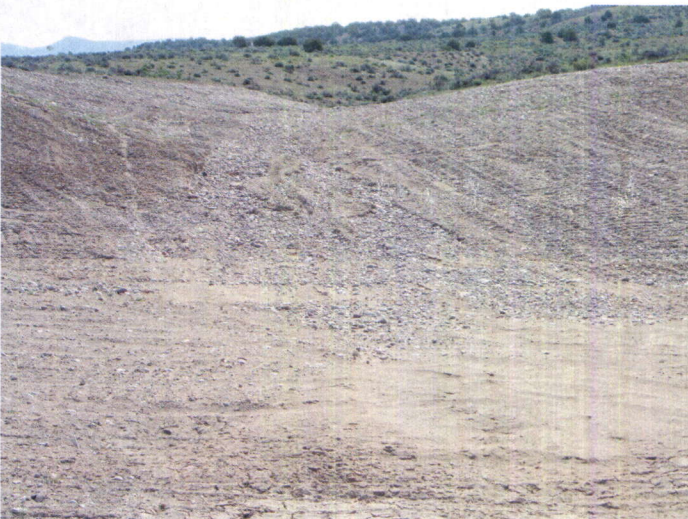
< image 6 view to east of intermittent drainage (pointed to by blue arrow in image 3) that has had water flow through it since the reshaping of the expired project area.

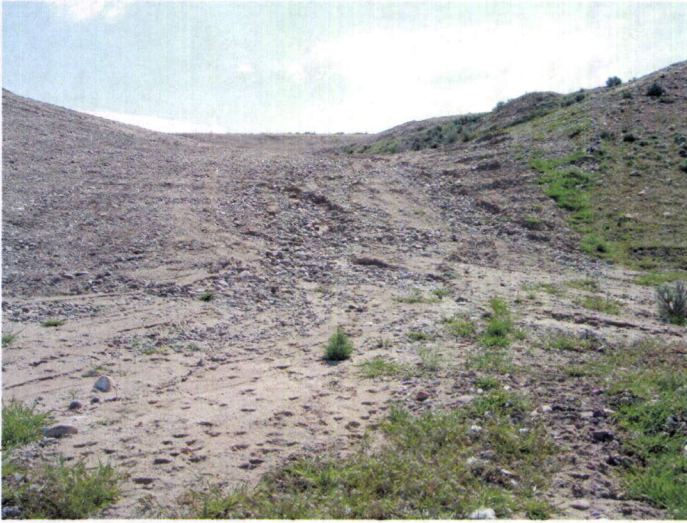
< image 7 view to east of intermittent drainage (pointed to by black arrow in image 1) that has had water flow through it since the reshaping of the expired project area.
